CITY OF BALTIMORE SMOKE TESTING OBSERVATION SUMMARY LOW LEVEL SEWERSHED

BALTIMORE CITY PROJECT 1029 REI/DRAYCO

Unique Test ID: 538 Date: 08/12/2008 Basin: LL - 42 Manhole ID: S19W_027MH Defect No: OB01 Supervisor: E.R. Crew: 04 Dye Test Recommended: N

Location: 2320 JAMES ST.

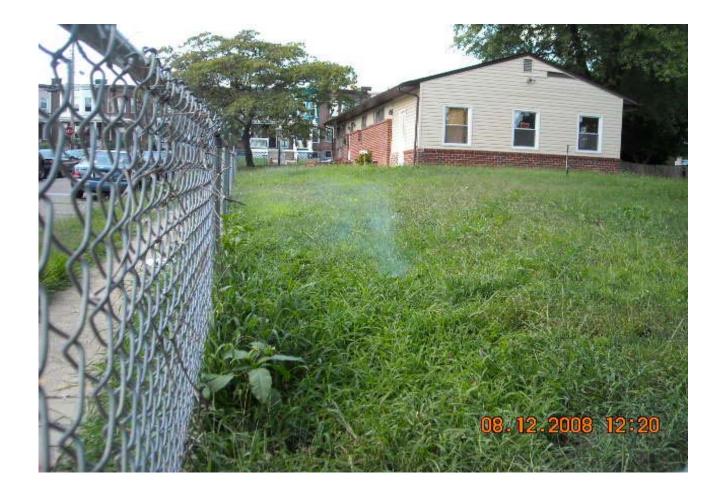
Photograph No: OB01-01 Filename: 1029-538_OB01-01.jpg

Source Type: 03 Cleanout Location: 09 Yard - Side

Sector: 02 Private Severity: 03 Moderate Drainage Area: 3

Comments: SMOKE COMING FROM AT GRADE CLEANOUT IN SIDE YARD.
